RIVERSIDE PARK (OU1)  
SUPPLEMENTAL CHARACTERIZATION  
AD-000594  
11-1-10  
S. WILSON & K. MCKENZIE

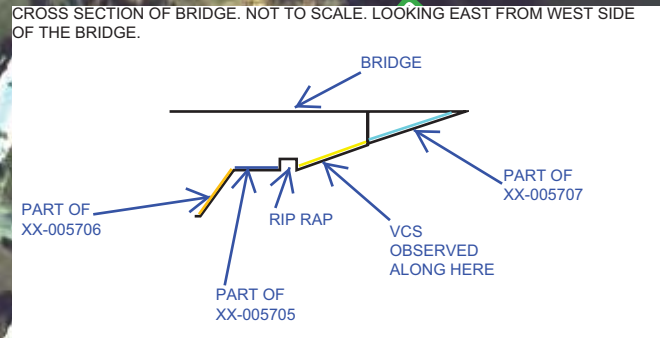
DUE TO AERIAL PHOTO NOT SHOWING SITE FEATURES, THE FOLLOWING NOTES ARE TO HELP EXPLAIN THE BOUNDARIES OF THE AREAS INSPECTED.

2D-04056 / XX-005705: ACCESS ROAD - NORTH BOUNDARY IS THE TOP OF THE SLOPE DOWN TO THE KOOTENAI RIVER. SOUTH BOUNDARY IS TO THE RIP RAP RUNNING ALONGSIDE THE ACCESS ROAD. EAST BOUNDARY IS TO WHERE THE EXCAVATION STOPPED AT 377 THOMAS ST (REMOVAL WAS IN JUNE 2010). IT INCLUDED AN AREA THAT WAS LIMITED USE (TALL GRASS) ALONG THE BANK NEXT TO 377 THOMAS ST.

2D-04057 / XX-005706. LUA, RIVER BANK. NORTH WEST BOUNDARY IS THE OLD BOAT RAMP, FROM THE TOP OF THE BANK DOWN TO THE WATERLINE OF THE KOOTENAI RIVER. AREA WENT TO IN LINE WITH THE GUY WIRE FROM THE POWER POLE NEXT TO 377 THOMAS ST. AREA IS VERY STEEP.

2D-04058 / XX-005707. LUA. EAST SIDE OF THE BRIDGE, INCLUDING THE SECTION UNDER THE BRIDGE THAT IS CLOSEST TO TOWN (SEE CROSS SECTION).

2D-04059 / XX-005708. LUA. AREA ALONG EMBANKMENT, FROM TOP TO WHERE THE EXCAVATION STOPPED AT THE 377 THOMAS ST REMOVAL. AREA IS VERY STEEP.

XX-005557. LUA. 3 AREAS WHERE VCS WAS OBSERVED. (1) AREA ALONG EMBANKMENT, FROM TOP TO WHERE THE EXCAVATION STOPPED AT THE 377 THOMAS ST REMOVAL. AREA IS VERY STEEP. (2) ALONG THE KOOTENAI RIVER. VERMICULITE WAS OBSERVED RIGHT ALONG THE WATERS EDGE, AND WAS SAMPLED AROUND. (3) AREA WEST OF THE BRIDGE THAT HAD NOT BEEN PREVIOUSLY CHARACTERIZED (THIS IS THE SLOPE AWAY FROM THE HIGHWAY). ALSO INCLUDED PART OF BELOW THE BRIDGE (SEE CROSS SECTION)
